SERVICE BULLETIN

TS-430S LOW/INTERMITTENT RX

10-18-85

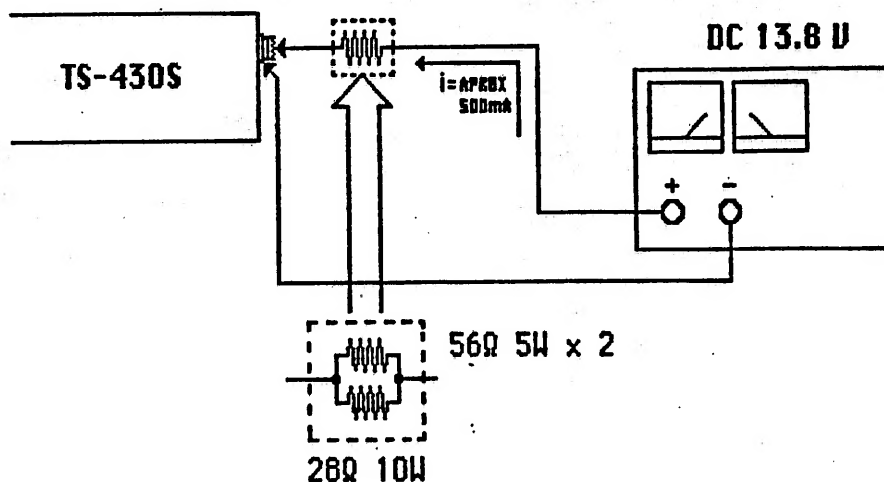
Low or intermittent receive on the TS-430S may be caused by a poor contact on one or more of the LPF relays. In most cases the following procedure will correct this problem without having to replace relays. The procedure has two steps, first initial cleaning of the contacts by passing a relatively high current thru them (about 500 mA), and then installing a contact maintenance circuit that will apply a relatively low current (about 8 mA) whenever a new band is selected.

1. Press and hold the "UP" bandswitch of the TS-430S (ensure the 1 Mhz switch is ON).
2. Apply 13.8 vdc to the antenna terminal thru a 28 Ω, 10 W resistor for approximately 1 minute. This will cycle thru all the relays and burn any oxidation/contamination from the contacts.
